INDOOR AIR QUALITY ASSESSMENT

**Massachusetts Criminal Justice Training Council
at the
Boylston Town Offices Building
221 Main Street
Boylston, Massachusetts**

Prepared by:
Massachusetts Department of Public Health
Bureau of Environmental Health Assessment
August, 2000

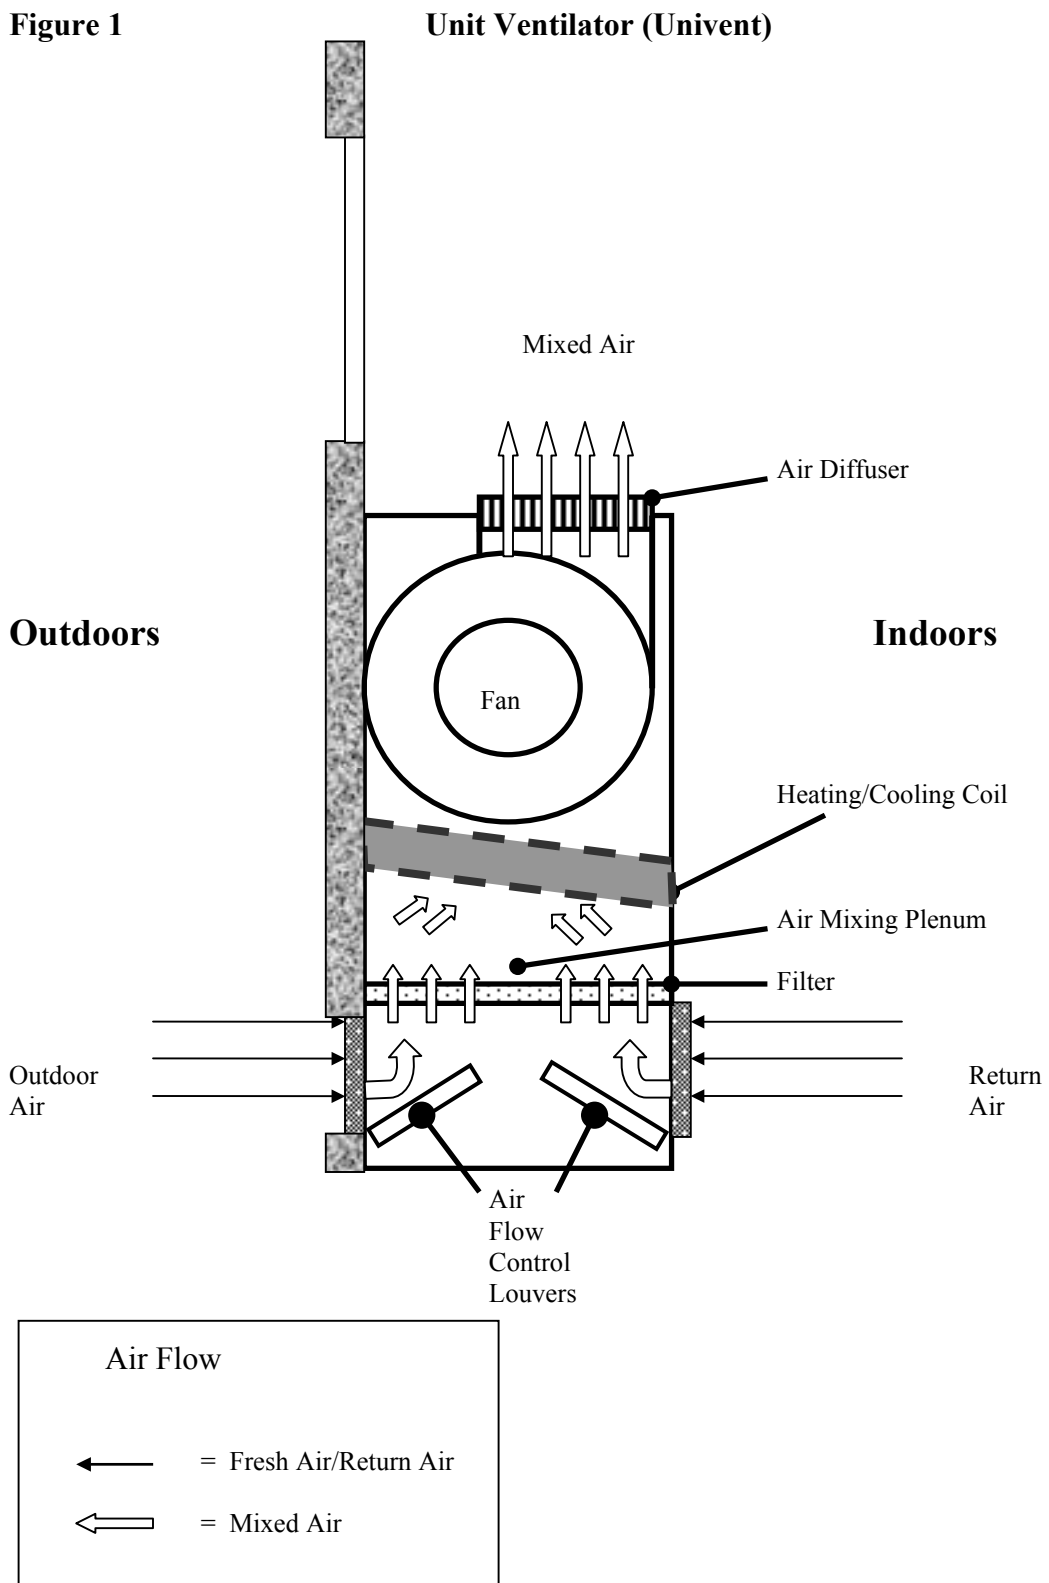
Figure 1

It can be seen from the tables that carbon dioxide levels were elevated above 800 parts per million (ppm) in two of five areas surveyed, which is indicative of a ventilation problem in these areas. Fresh air is supplied by a mechanical unit ventilator (univent) system ([see Figure 1](#)). Univents were not operating during the assessment. Of note was classroom 1BTO201, which had a carbon dioxide level over 2,000 ppm, indicating little air exchange in this room. To function as designed, univents and univent returns must remain free of obstructions. Importantly, these units must be activated and allowed to operate while rooms are occupied.

1. Operate univents while classrooms are occupied.
2. Seal passive vents in hallway doors.
3. Examine the feasibility of providing mechanical exhaust ventilation for high occupancy meeting rooms to remove heat and moisture from these areas.

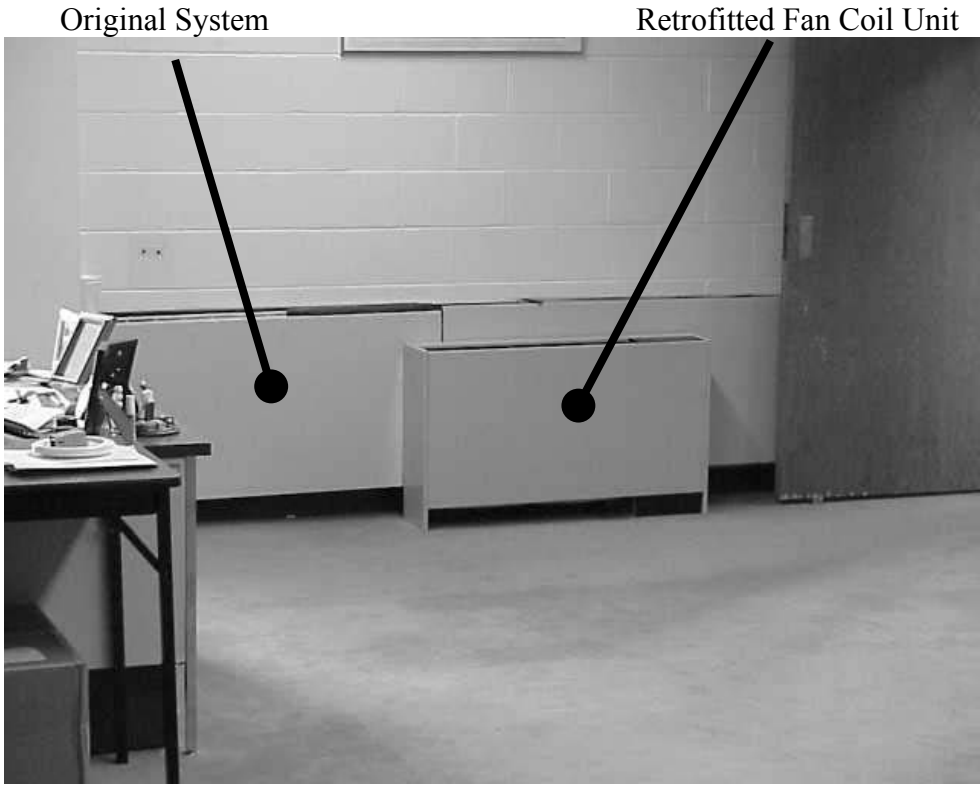
Picture 1

It appears that additional fan coil units (FCUs) were retrofitted into the heating pipes in the large meeting rooms on the second floor (see Picture 1). These FCUs were not part of the original HVAC system, but were believed installed during the DEC occupancy of the building. Each of these FCUs appears to be equipped to provide both heat and air conditioning. The FCUs do not supply fresh air, but rather only heat or cool recirculated air.

Fan Coil Unit Retrofitted into Original Heating System

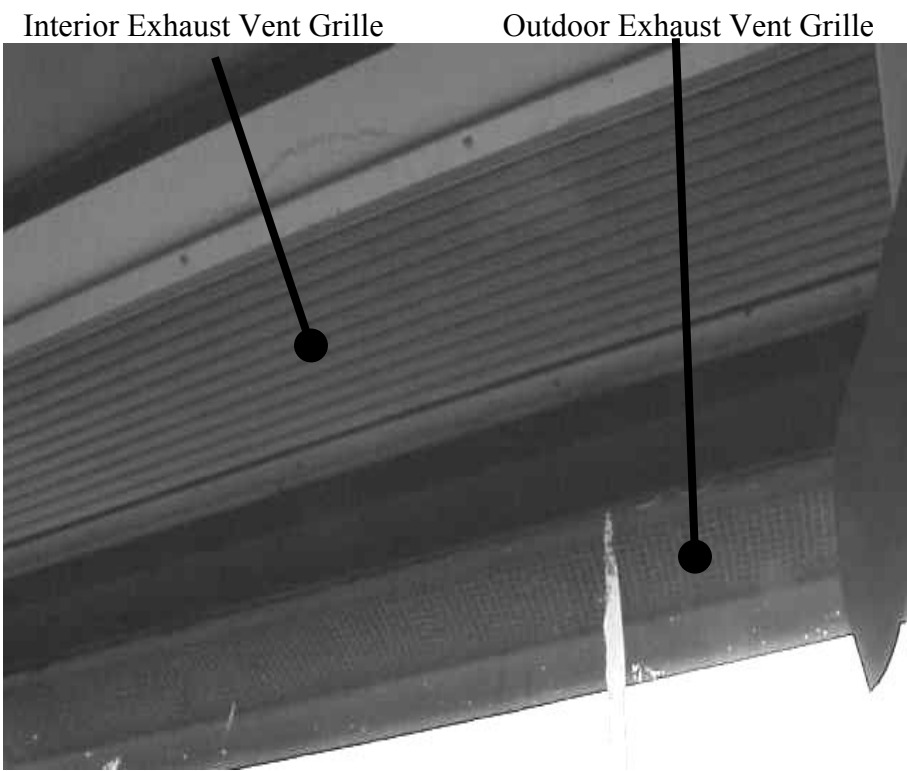
Picture 2

With the exception of restrooms, no mechanical exhaust ventilation system exists in this building. Second floor rooms have a passive non-mechanical exhaust vent located over windows (see Picture 2). In order to function, this ventilation system relies on positive pressure created by the univent to force air out of the passive vent. As the univent operates, air pressure increases as additional fresh air is introduced into the classroom (called positive pressure). As positive pressure increases, air is forced out of the room through wall and door spaces. The passive vent is designed to allow for slow release of air from classrooms by increasing positive pressure created by the univent. The design of these exhaust vents requires that classroom hallway doors remain closed as much as practical in order to maintain positive pressure. With hallway doors open, classroom air would be forced into hallways. In addition, several of these passive vents were examined and were noted to be

backdrafting cold air into classrooms. Previous experience indicates that these types of systems tend to backdraft cold air during winter months. Without a mechanical system, these vents may not function to provide exhaust ventilation and be a source of cold air during winter months. In order to have these vents operate as designed, doors and windows must remain closed in classrooms equipped with these vents.

Passive Exhaust Ventilation System in Second Floor Rooms

4. Service the louvers of the exhaust vents. Remove wasp nests from vents if present.
5. Examine the feasibility of replacing drip pans in univents.
6. Replace water damaged pipe insulation.

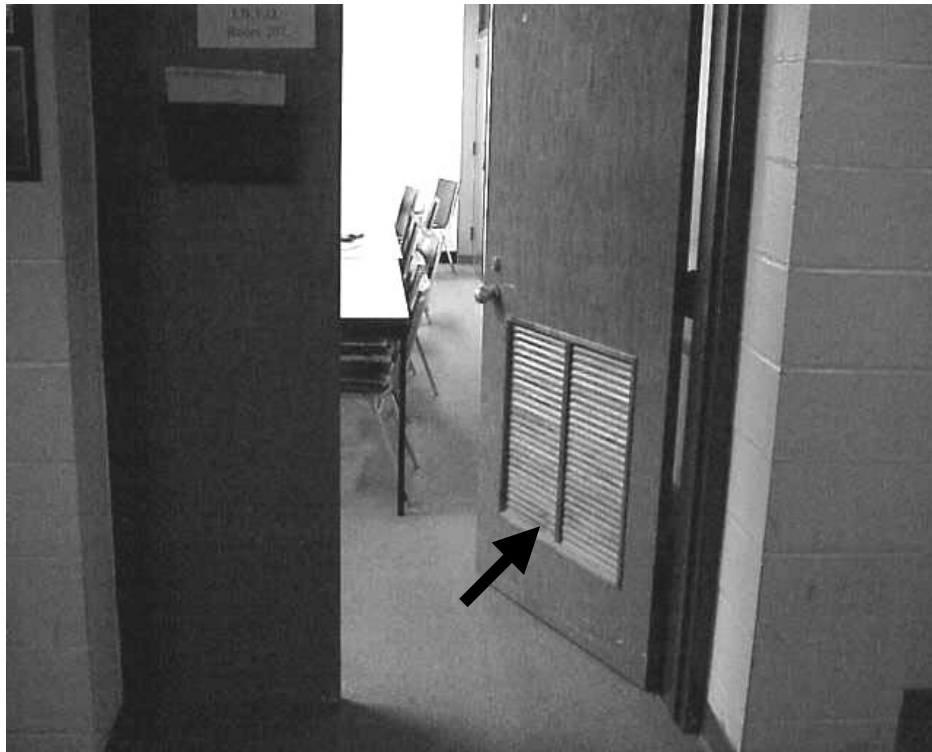
Picture 3

With the absence of active mechanical exhaust ventilation, pollutants generated during building occupancy will tend to linger in classrooms. Degrading the ability of the HVAC system to create positive pressure in the MCJTC classrooms are the existence of passive vents in the base of hallway doors (see Picture 3). Since air can readily flow through these vents even with classroom hallway doors closed, the HVAC system will have a difficult time building up positive pressure to expel air through the passive exhaust vents above windows.

Passive Vent in Hallway Door MCJTC Classroom

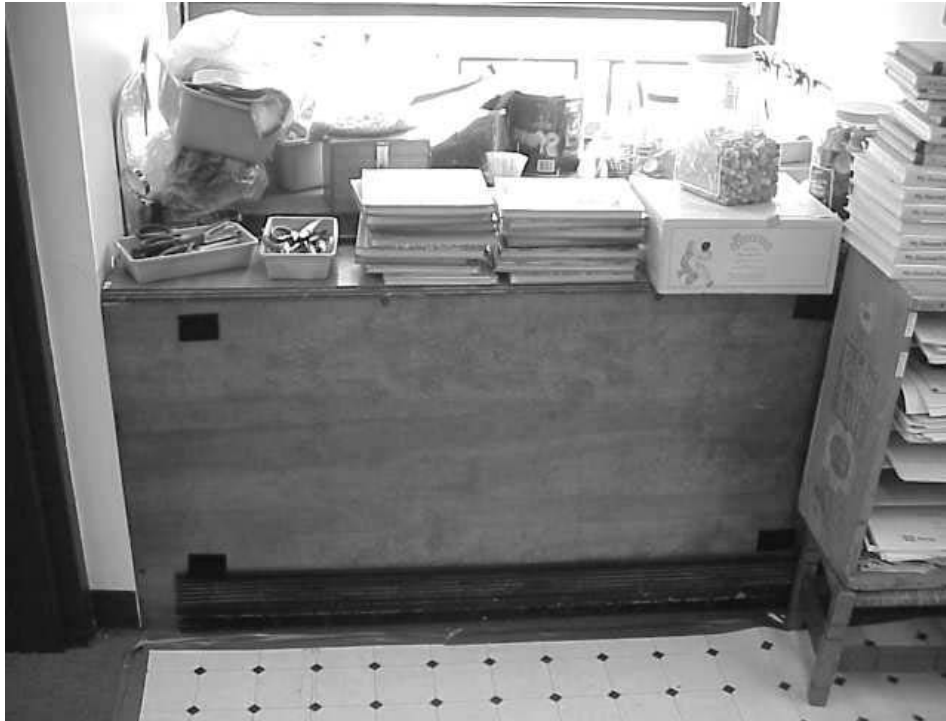
Picture 4

Of note is the univent design. Instead of installing univents as a complete metal case, it appears that the internal workings of a univent were encased in specially built wooden cabinets (see Picture 4). Within these cabinets are pipes clad with fiberglass insulation (see Picture 5). Since these univents can provide chilled air during warm months, moist air introduced into these wooden cabinets can result in the wetting of the insulation paper. It appears that mold may have colonized the insulation paper (see Picture 6). This colonization may be a source of spores and other mold-related particulates, which can be aerosolized by the univent. Other sources of mold colonization of pipe insulation exist in the gymnasium (see Picture 7). Leaks from the heating system resulted in active mold growth on the exterior of the insulation.

Univent in Wooden Casing

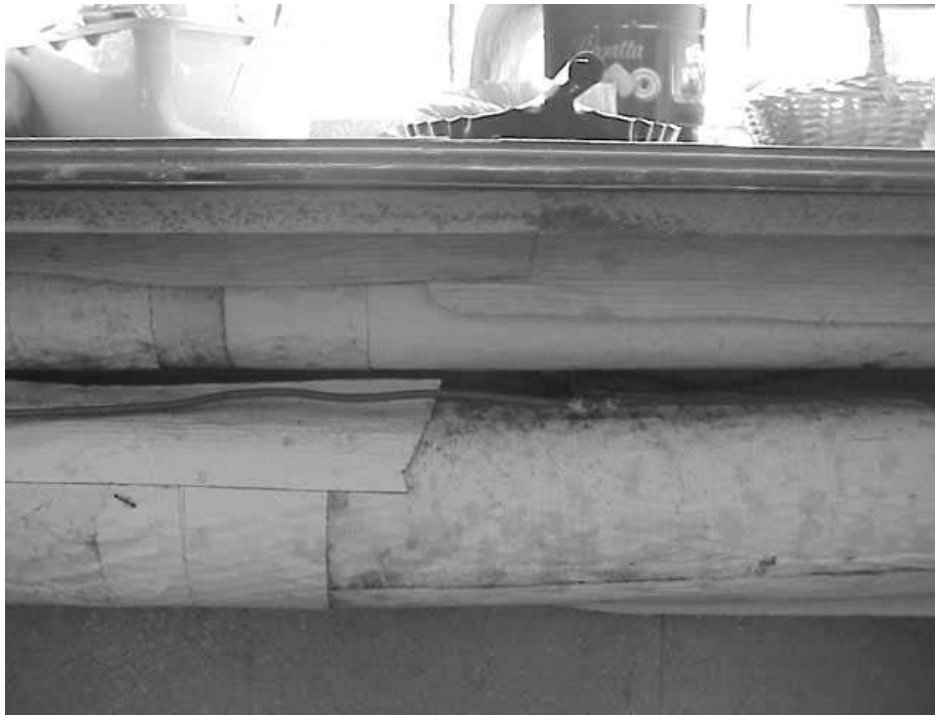
Picture 5

Insulated pipes in Wooden Univent Cabinet, Note Stains/Possible Mold Growth

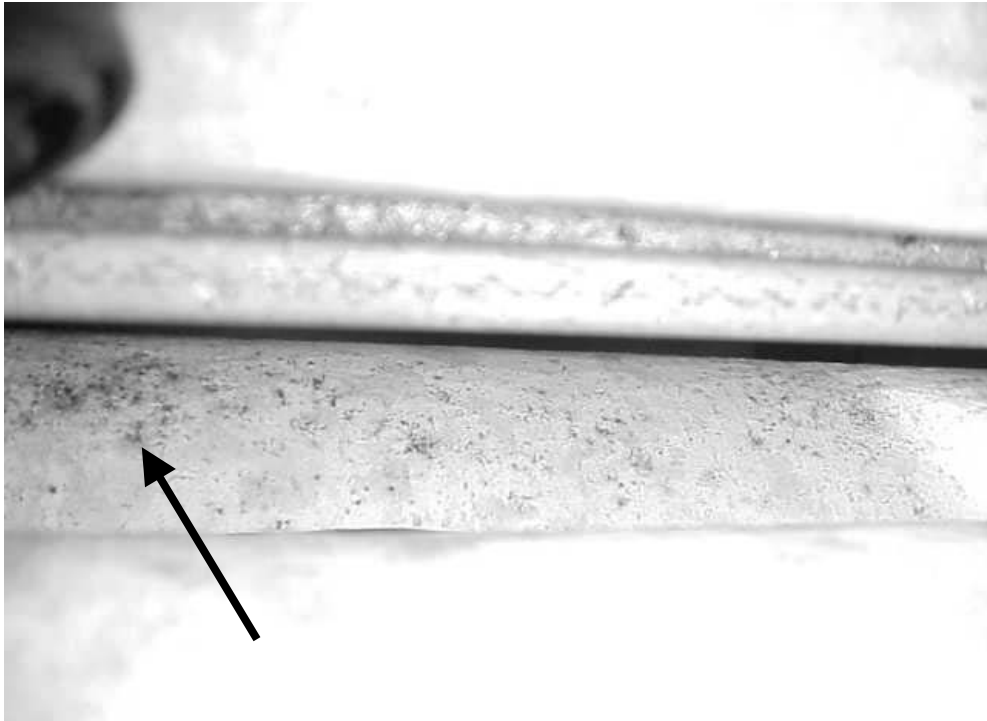
Picture 6

Paper of Pipe Insulation, Note Possible Mold Colonies

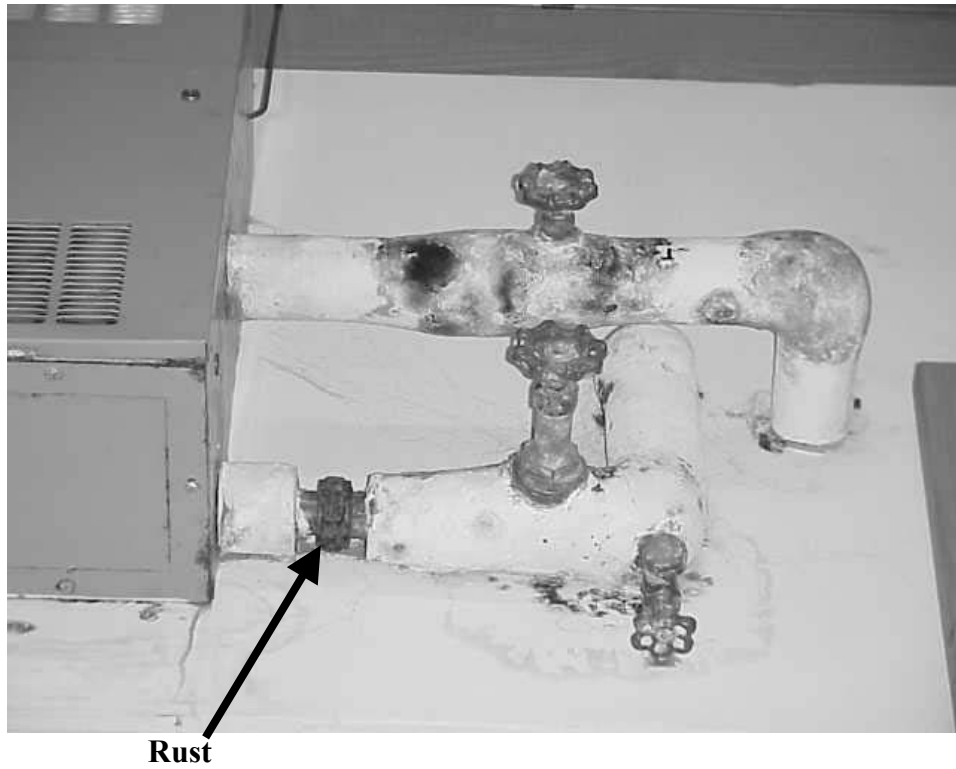
Picture 7

Possible Mold Colonization of Insulation, Note Rusted Exposed Pipe That Indicates Possible Condensation Production

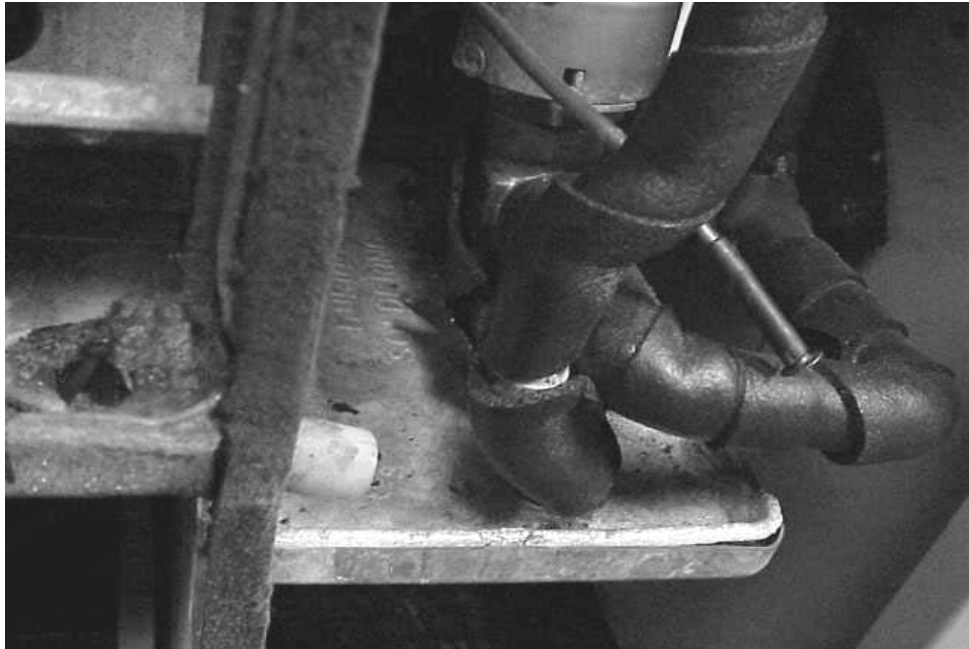
Picture 8

Each univent is equipped with drip pans to collect and drain condensation from cooling coils. The manufacturer of these univents provided a styrofoam liner to protect the drip pans from water damage. These styrofoam liners have never been replaced since the installation of the univents (see Picture 8). The accumulation of debris in these drip pans can serve as growth media for mold.

Drip Pans in Univent with Accumulated Debris
